**Summary Report  
Condition Reassessment and  
Post Tension Strand Evaluation  
25 Sigourney Street  
Hartford, Connecticut**

**DCS Project No. BI-2B-034A  
Architects Project No. 206063**

**13 October 2011**

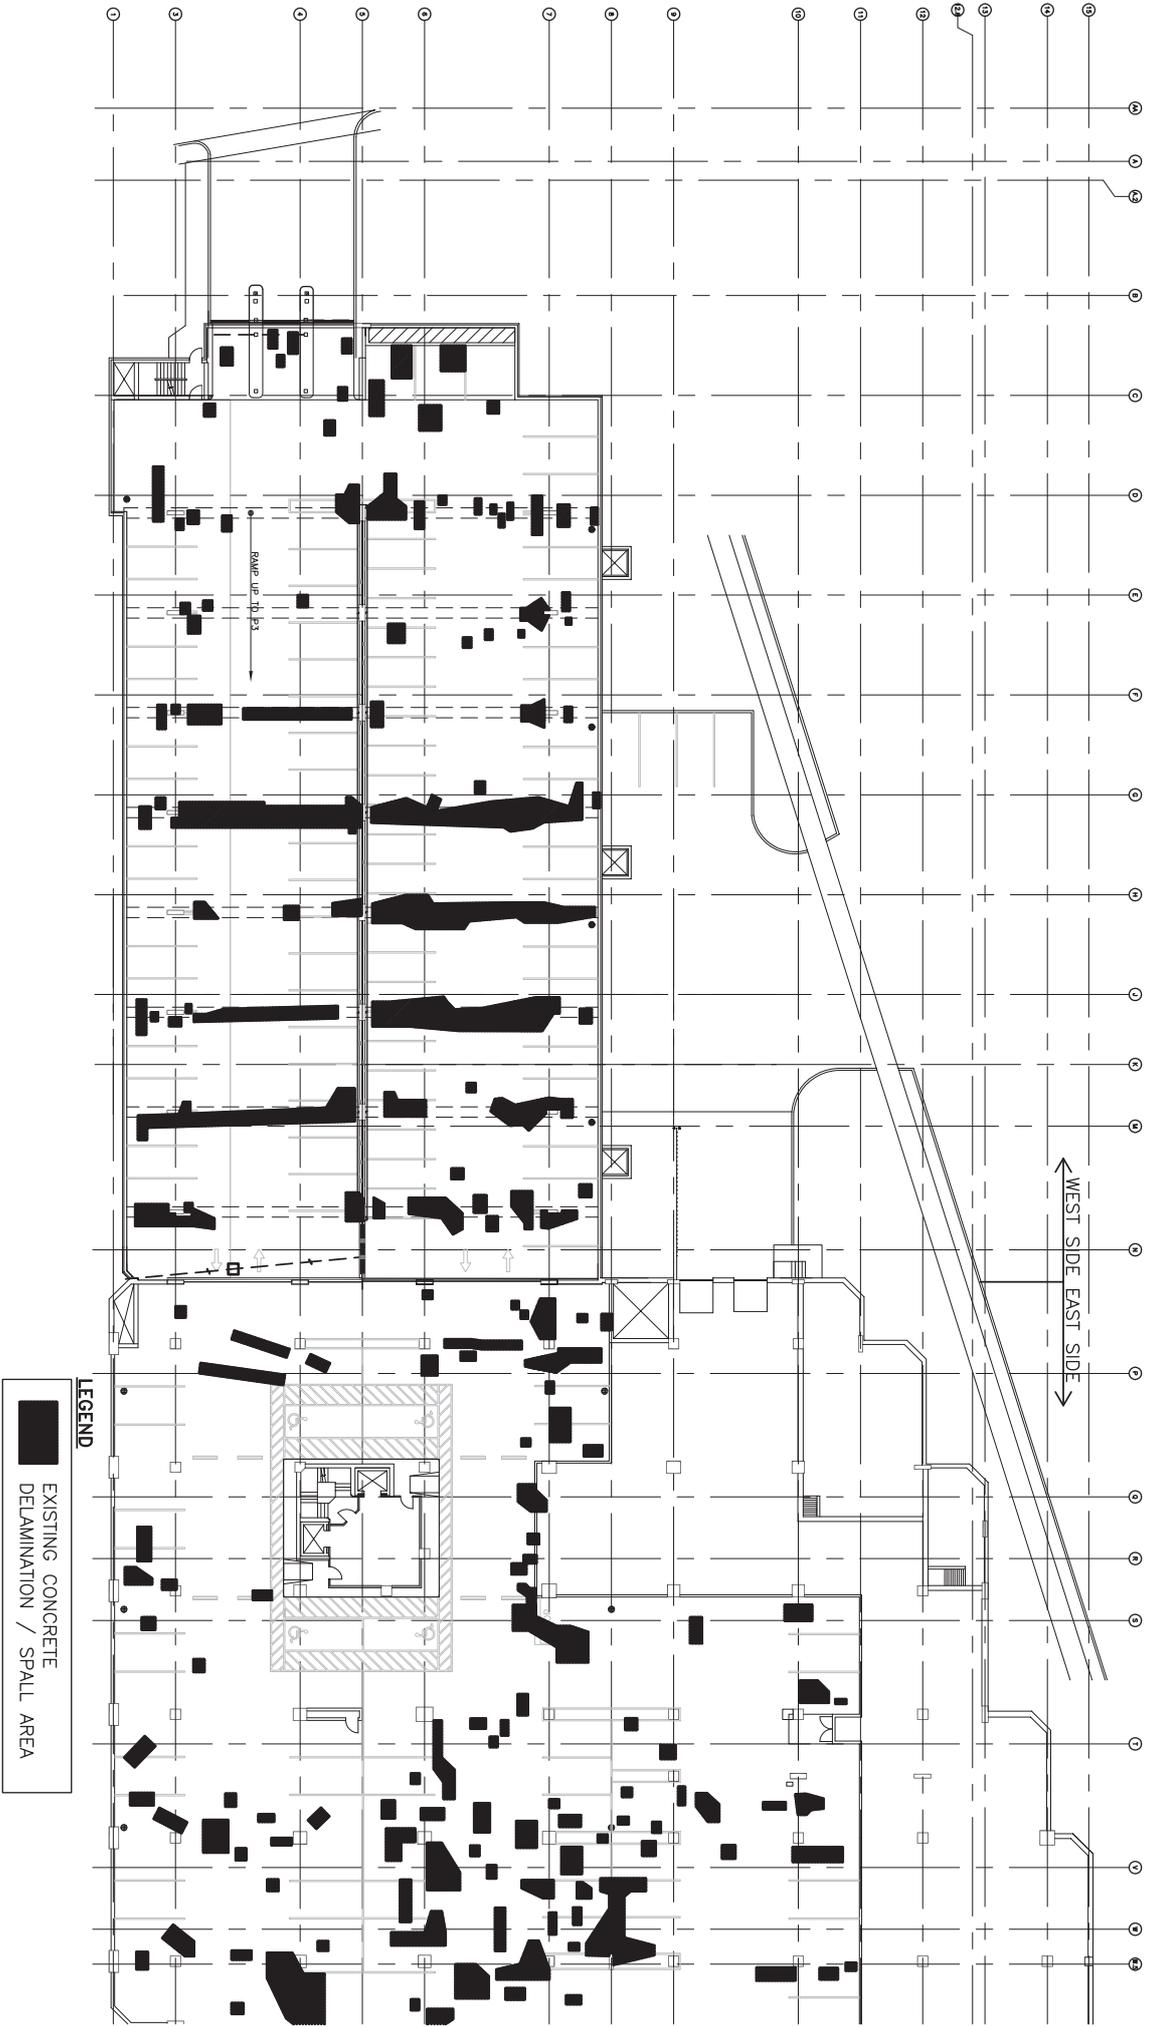
**2** PARKING LEVEL P2 - 2011 DECK LAMINATION SURVEY  
SCALE: 1/32" = 1'-0"

A sounding [lamination] survey was conducted to determine the extent to which laminations in the deck have either grown or multiplied since a sounding survey was last conducted at the garage 5 years ago. This sounding survey consisted of dragging heavy chain over the concrete deck surface and listening for hollow sounds indicative of corrosion induced lamination of the concrete. Based upon this more recent survey, detectable laminations have increased from 4,100 SF in September of 2006 to 17,300 SF in September of 2011. This is an alarming increase of over 320% in measurable deterioration within a 5 year period. Please refer to the Drawings section of this report for drawings showing the extent of laminations detected during the 2006 and current surveys. Both are provided to graphically demonstrate the magnitude of increase in deterioration to the garage.

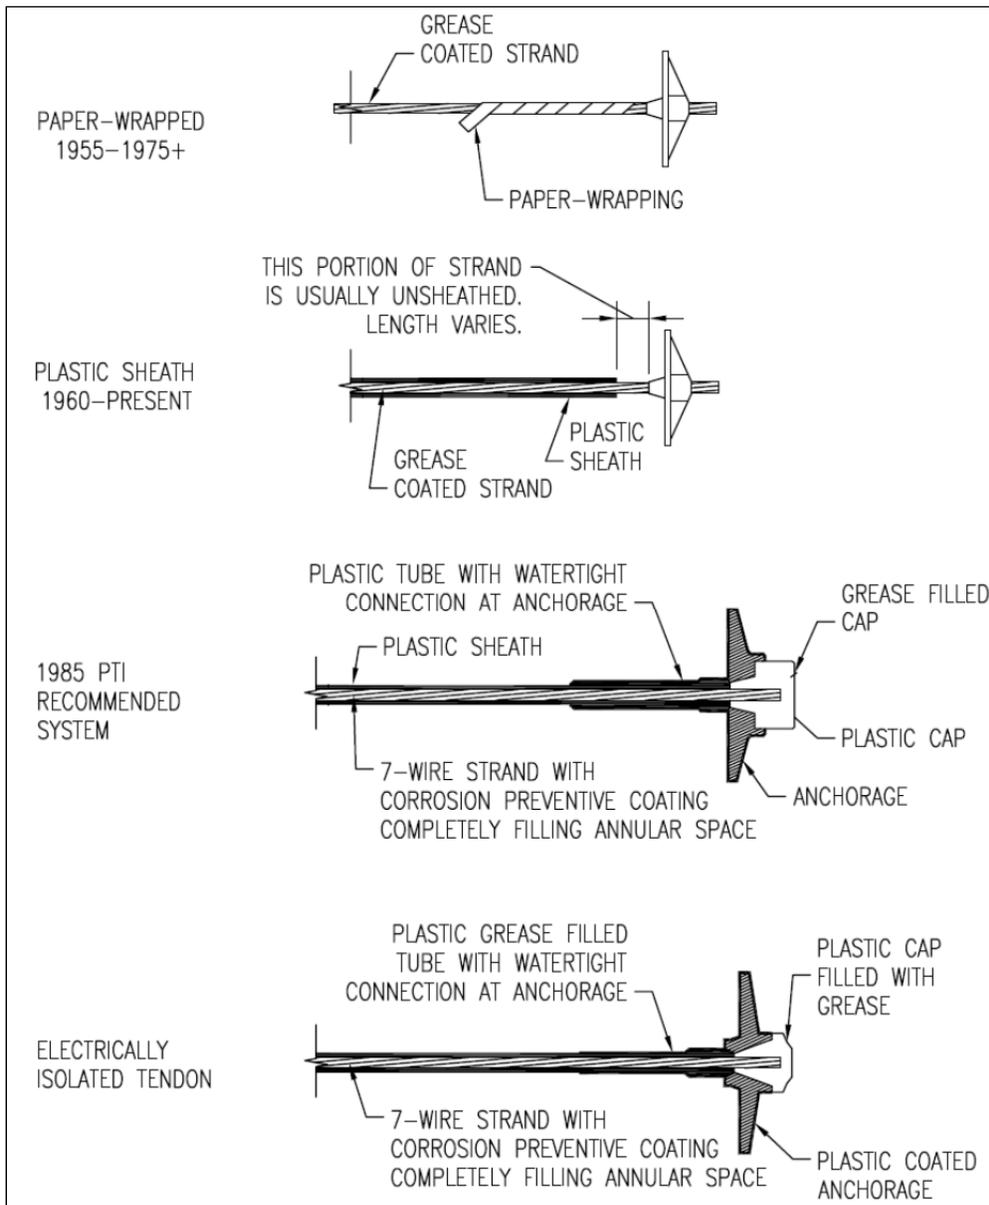
- Push-through sheathing did not form a tight seal around the strand, allowing water to collect at low points in the tendon trajectory;
- The sheathing did not extend to the anchorages, allowing chloride induced corrosion of these components;
- The end anchorages were uncoated and were installed in contact with the back-up reinforcing steel, further allowing corrosion of these components.

**Figure 1.** Deficiencies in corrosion protection details. 25 Sigourney St. uses the 2<sup>nd</sup> system from top. (Figure adopted from ACI 423.4R-98).

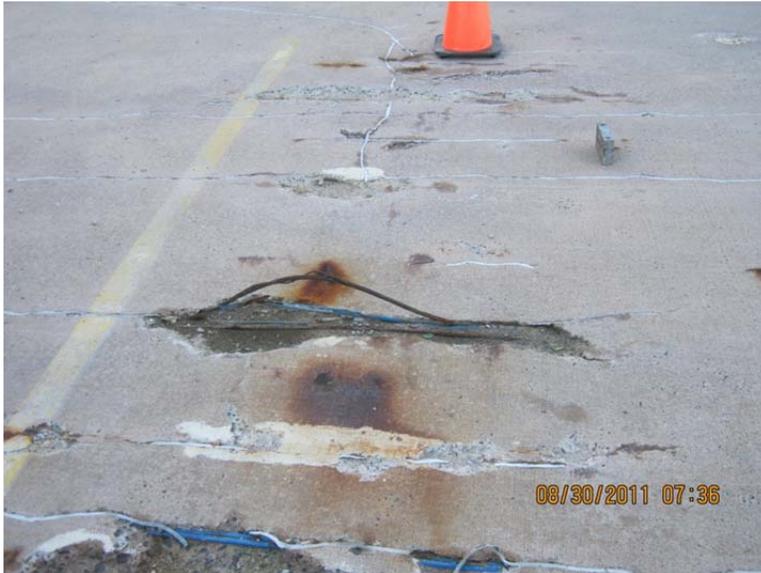
**Figure 5.** Failed post-tensioning on Level 6.

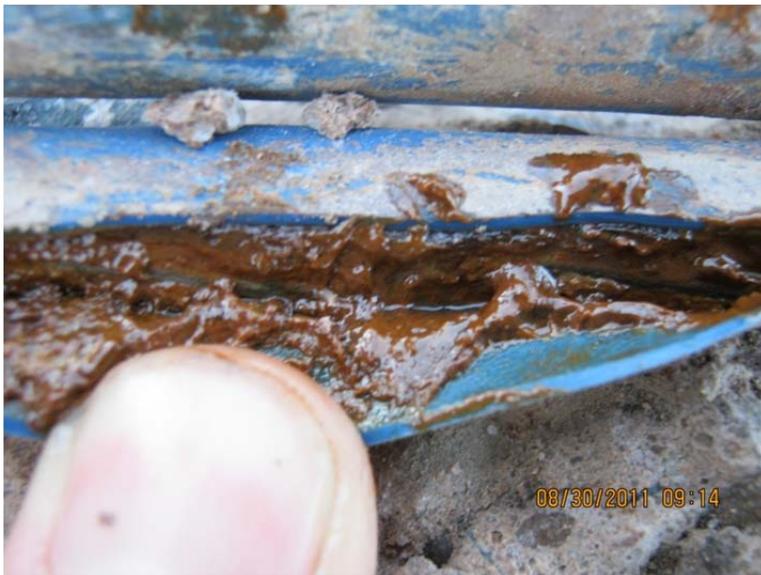
**Figure 6.** Emulsified grease on post-tensioning grease.

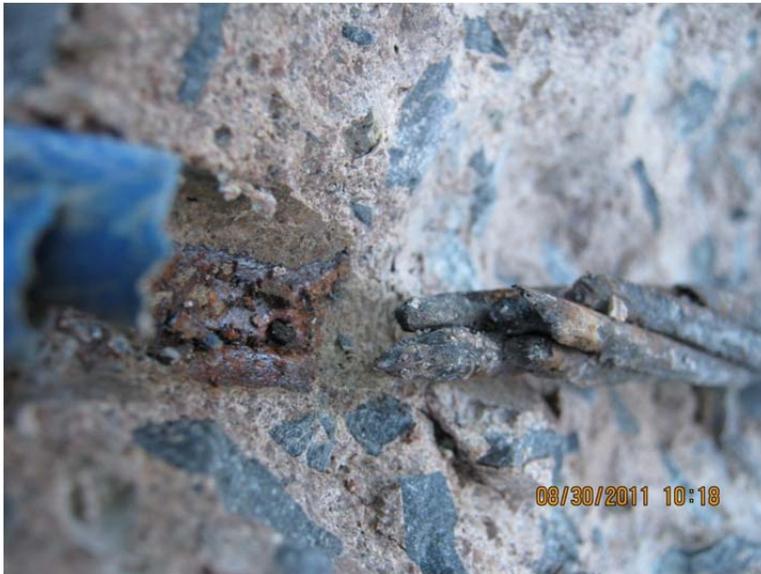
**Figure 7.** Brittle failure of post-tensioning strand on Level 6.

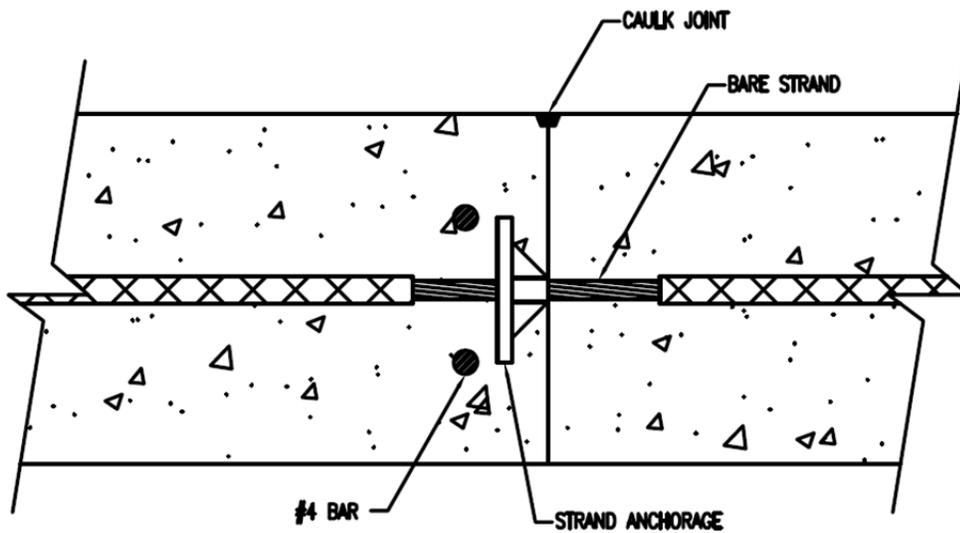
The probe openings on the top slab surfaces revealed that significant corrosion was present at the high points in the tendon trajectories in locations with low concrete cover. Figures 5 to 7 show typical conditions observed at low cover locations. Approximately twelve failed post-tensioning strands were observed on the top slab surfaces at various locations in the structure. Additional openings were made at the construction joint where known deficiencies are present in the corrosion protection. These are shown in Figure 8.

**Figure 8.** Strand conditions at construction joint. Note lack of positive corrosion protection as strand crosses joint.

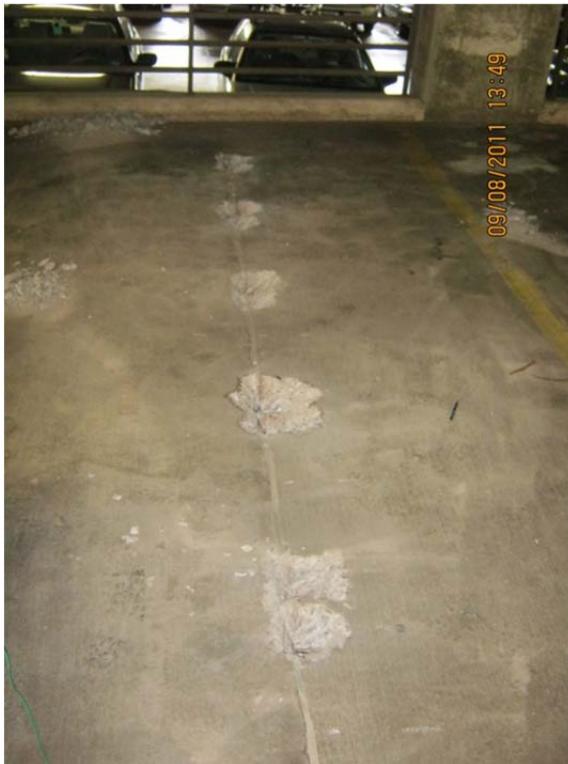
During the evaluation, a section on Level 2 was observed with several failed post-tensioning strands at the construction joint. The failed post-tensioning strands were

observed at the construction joint located between beam lines D and E. Two failed post-tensioning strands were present in this location, at the start of the investigation and water stains were observed on the slab soffit at the construction joint. Three additional broken strands were observed in this area (total of 5 broken strands). Wire breaks and section loss due to corrosion were observed at other locations. Based upon these observations, the area was closed to parking. Figure 9 to 13 show some of the observed conditions in the area. Based upon the observation of the failed strands, the area on the south half of Level 2 from column lines K to A was closed to parking, as well as the area on Level 1 immediately beneath this area.

Our initial calculations indicated that the isolated failure of up to two strands would not reduce the capacity of the slab to an unsafe level. After the observations of the failed strands on Level 2, additional calculations were performed to examine the capacity of the slab with failed post-tensioning strands. The calculations indicated that with a 50% loss (failure) in post-tensioning strands, the slab had adequate strength to resist dead loads only. Therefore the parking area must remain closed until the strands are repaired.

**Figure 9.** Openings at construction joint on Level 2.

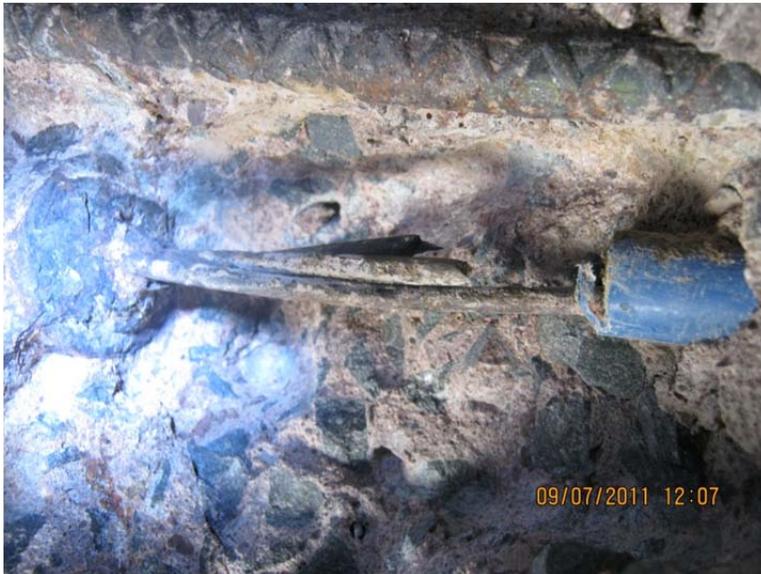
**Figure 10.** Failed strand at construction joint. Note corrosion on anchorage and failed wires.

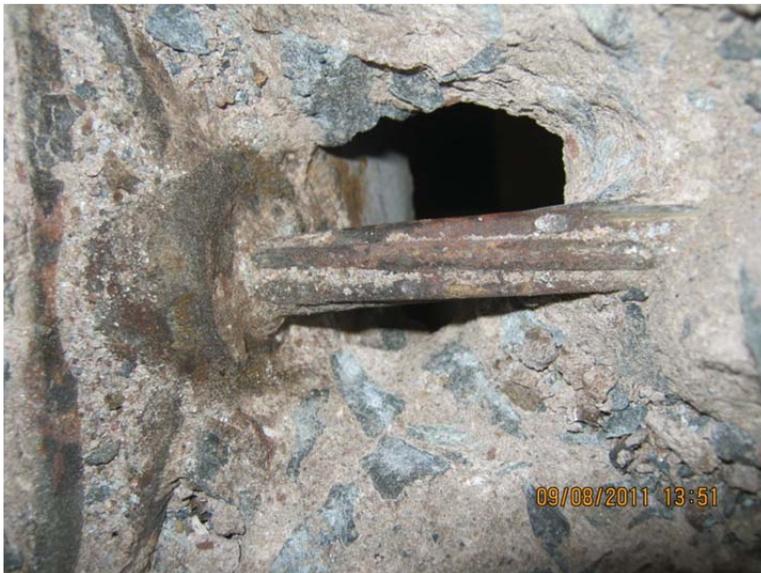
**Figure 11.** Corrosion damage on strand, without strand failure.

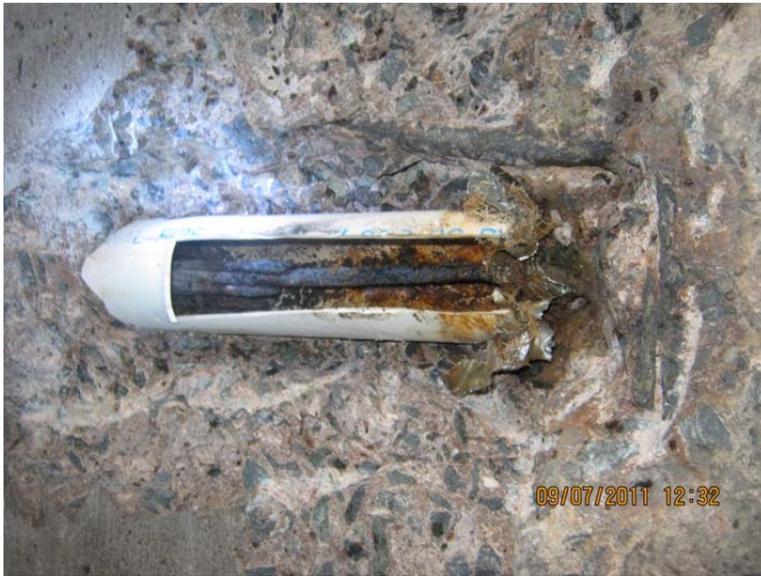
**Figure 12.** Failed strand at construction joint (possibly failed during original construction).

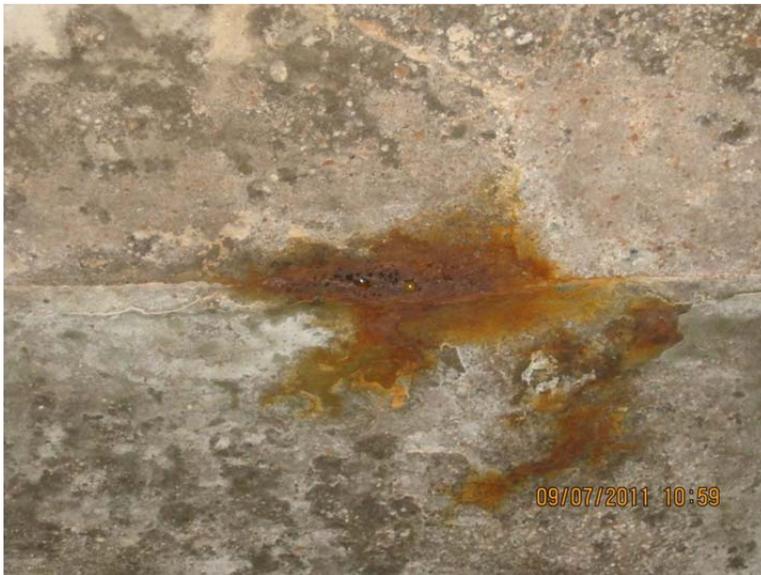
**Figure 13.** Water dripping through construction joint in vicinity of failed strands.

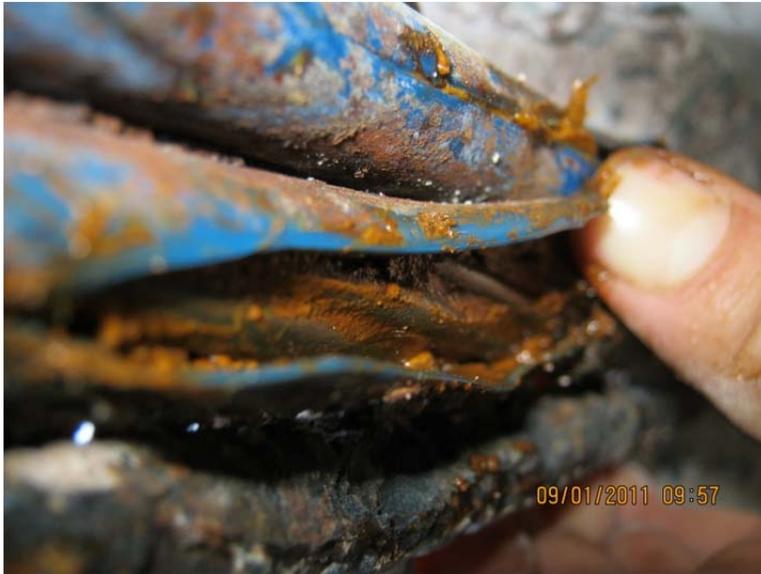
however surface corrosion was typically observed. Significant amounts of water and emulsified grease were also observed. Figures 14 and 15 show representative observed conditions on the slab soffits.

**Figure 14.** Water and emulsified grease on strand.

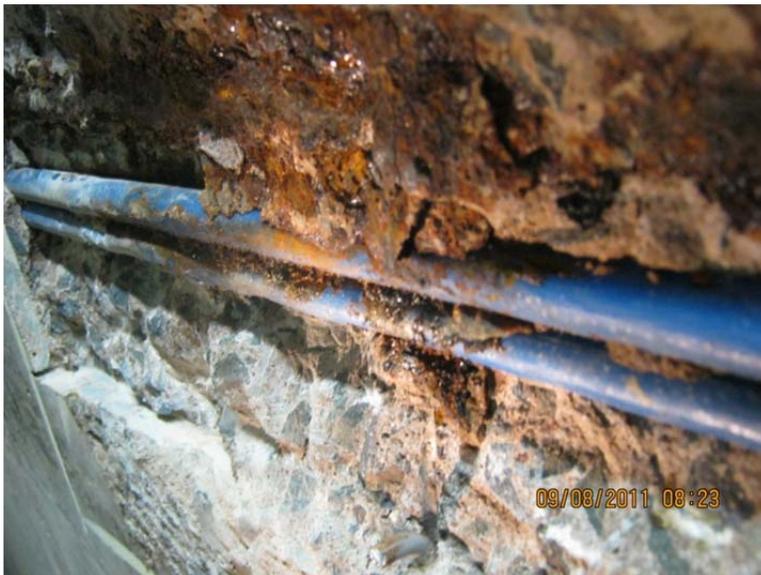
**Figure 15.** Corrosion damage to mild reinforcing steel and damage to sheathing on soffit.

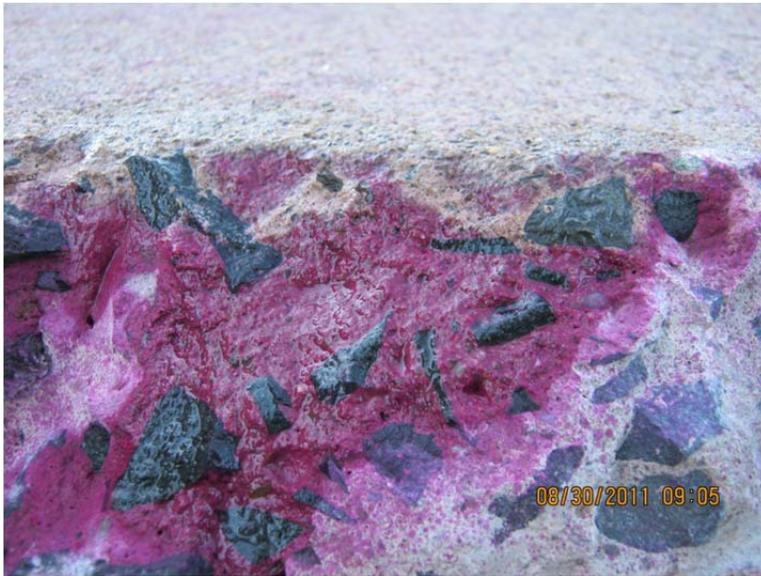
In addition to the chloride tests, carbonation tests were performed on freshly fractured concrete samples using a phenolphthalein solution. Figure 16 shows a tested area on Level 6, in the Figure the carbonation depth is less than ¼” as indicated by the change in indicator color. Similar carbonation results were obtained on tests on the lower levels. The limited carbonation depth was expected based upon the age of the structure and open construction.

**Figure 16.** Concrete surface on Level 6 with phenolphthalein applied.

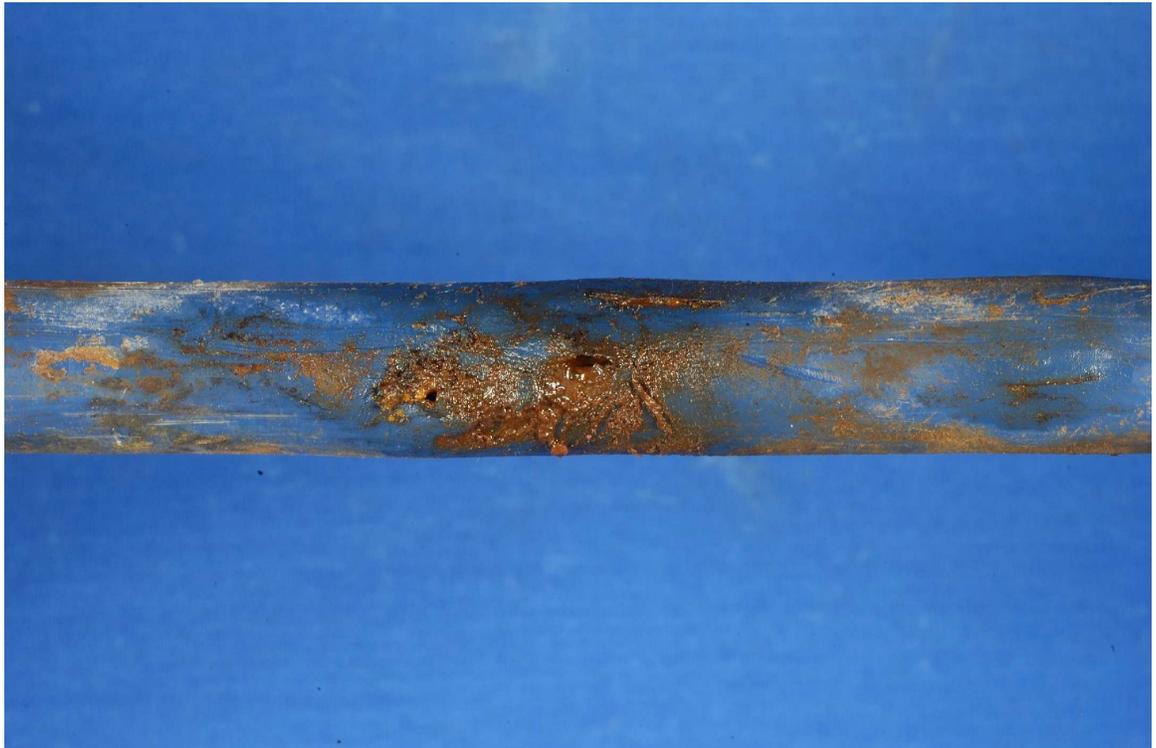
**Figure 1.** View of a portion of strand #1 identified as “L6 South E Centerline” at a location of damage to the polyethylene (PE) sheath where iron corrosion product stained grease is visible. L3607 093011 01

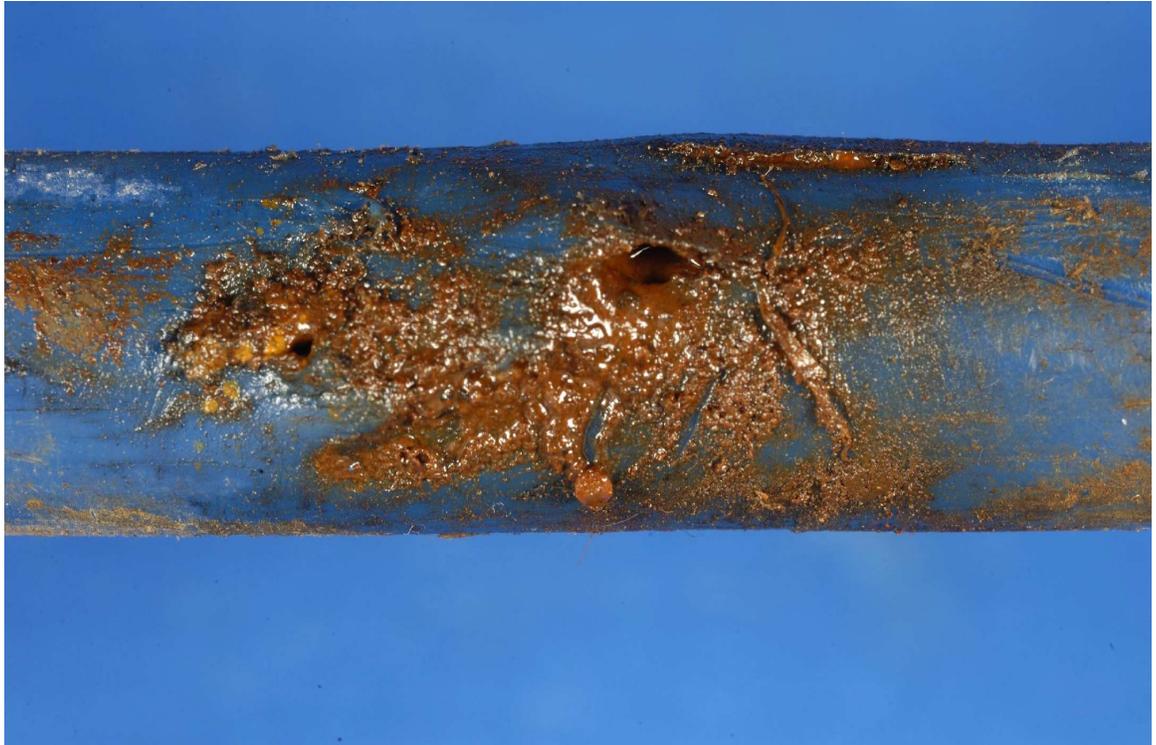
**Figure 2.** Close view of location shown in Figure 1. L3607 093011 02

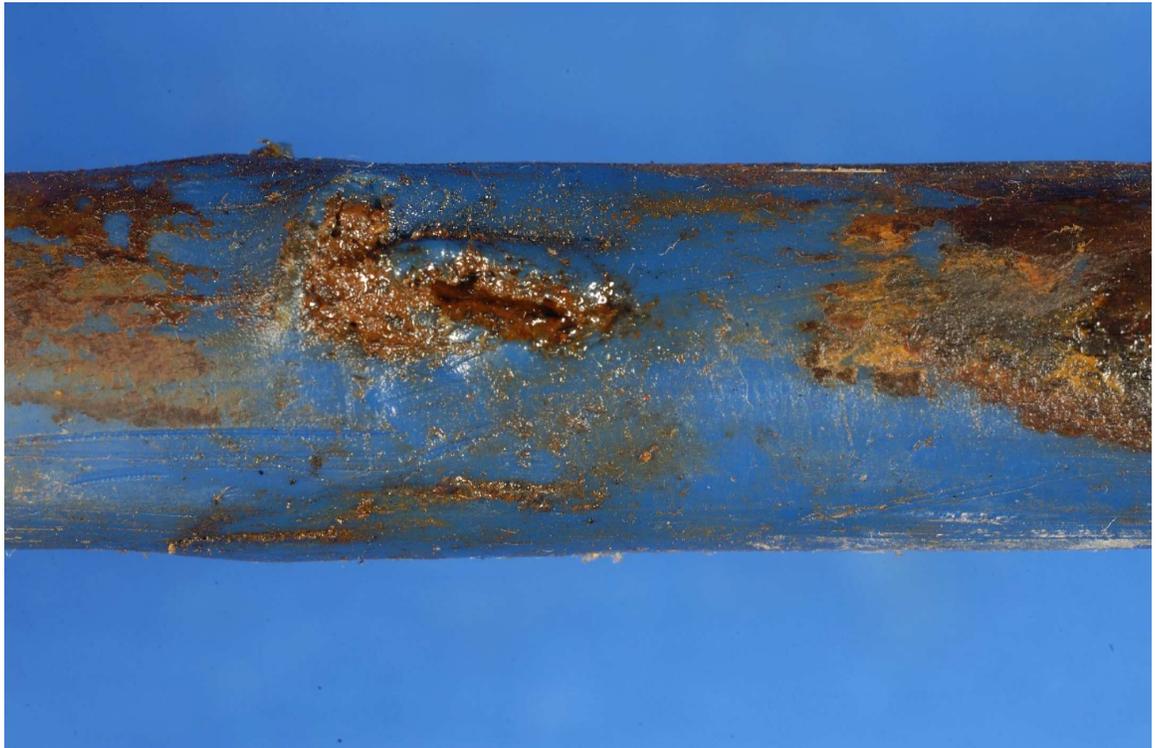
**Figure 3.** Second location of many on strand #1 showing evidence of sheath damage.

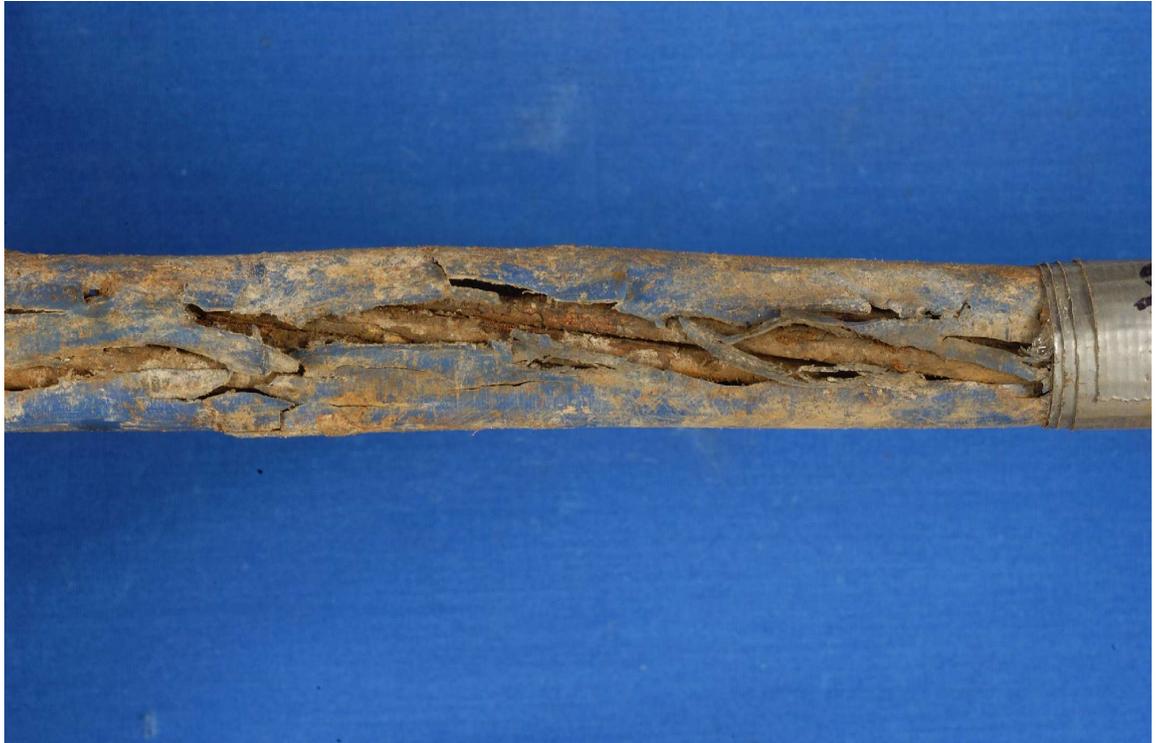
**Figure 4.** Severely damaged PE sheathing and visibly corroded strand wire on strand #2.

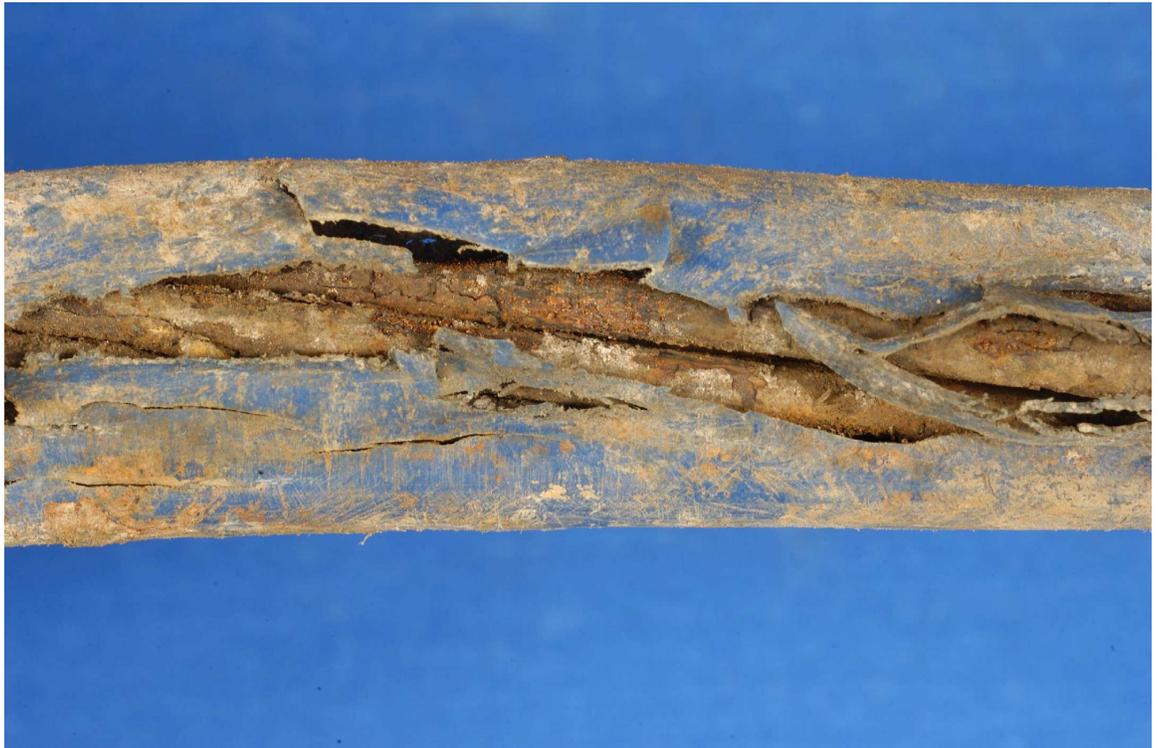
**Figure 5.** Close view of location shown in Figure 4. L3607 093011 05

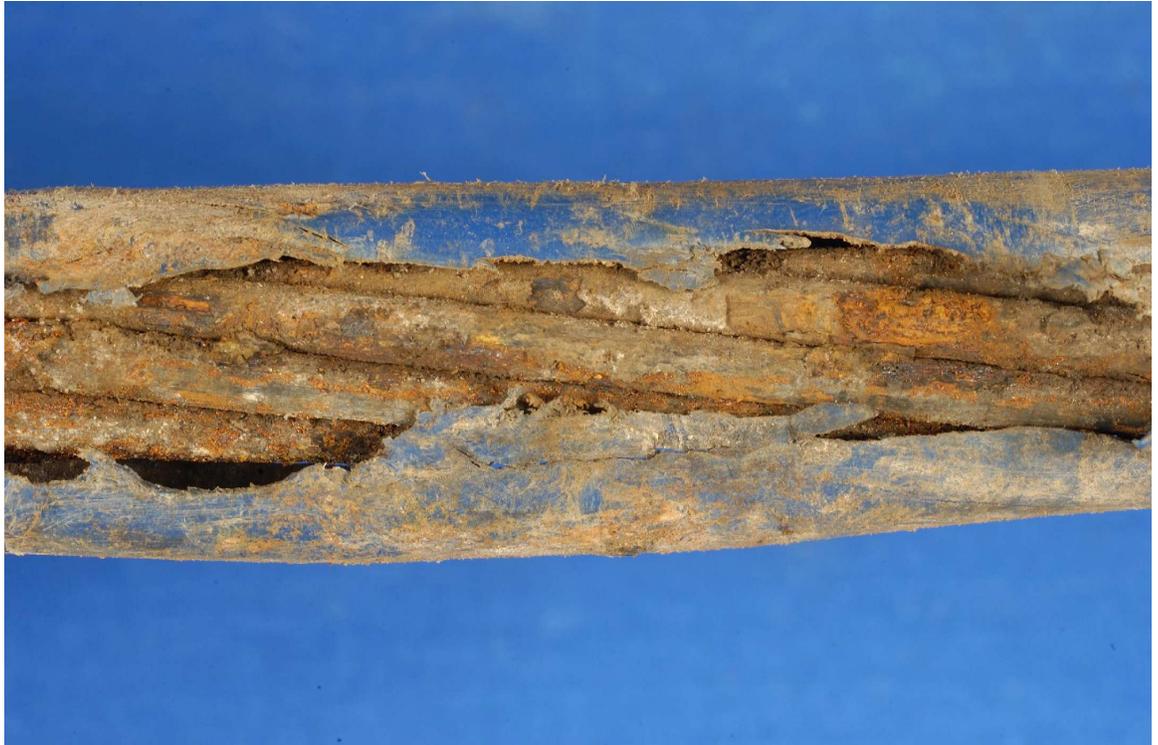
**Figure 6.** Second location of sheath damage and strand wire corrosion on strand #2.

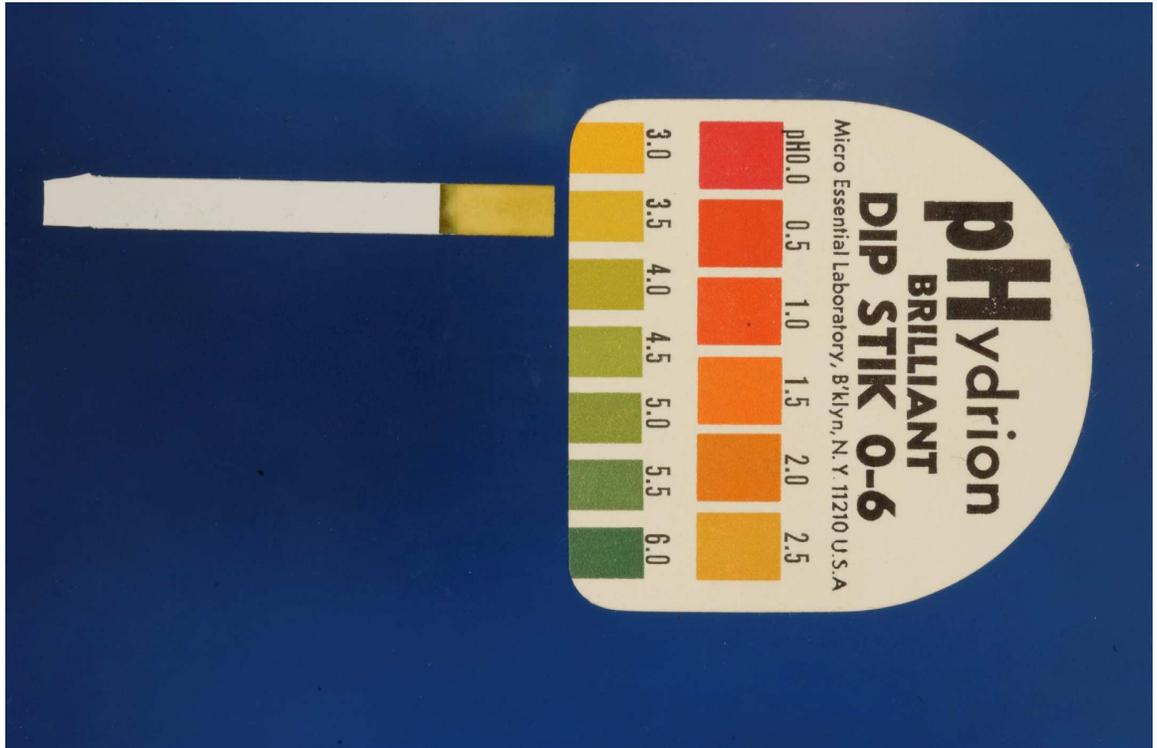
**Figure 7.** pH indication of 3.5 obtained on water sample prepared by mixing distilled water with finely ground corrosion products on strand #2. L3607 093011 07

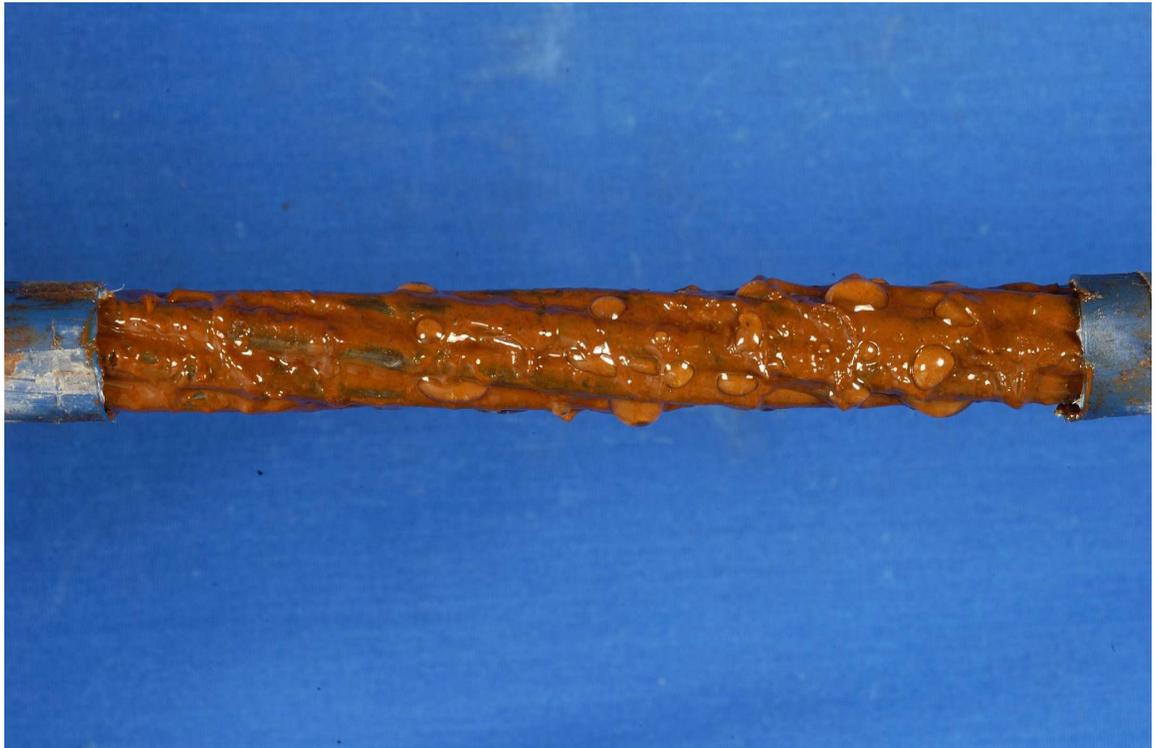
**Figure 9.** Section of sheathing removed on strand #1 where distilled water has been dripped onto the orange stained grease. L3607 093011 09

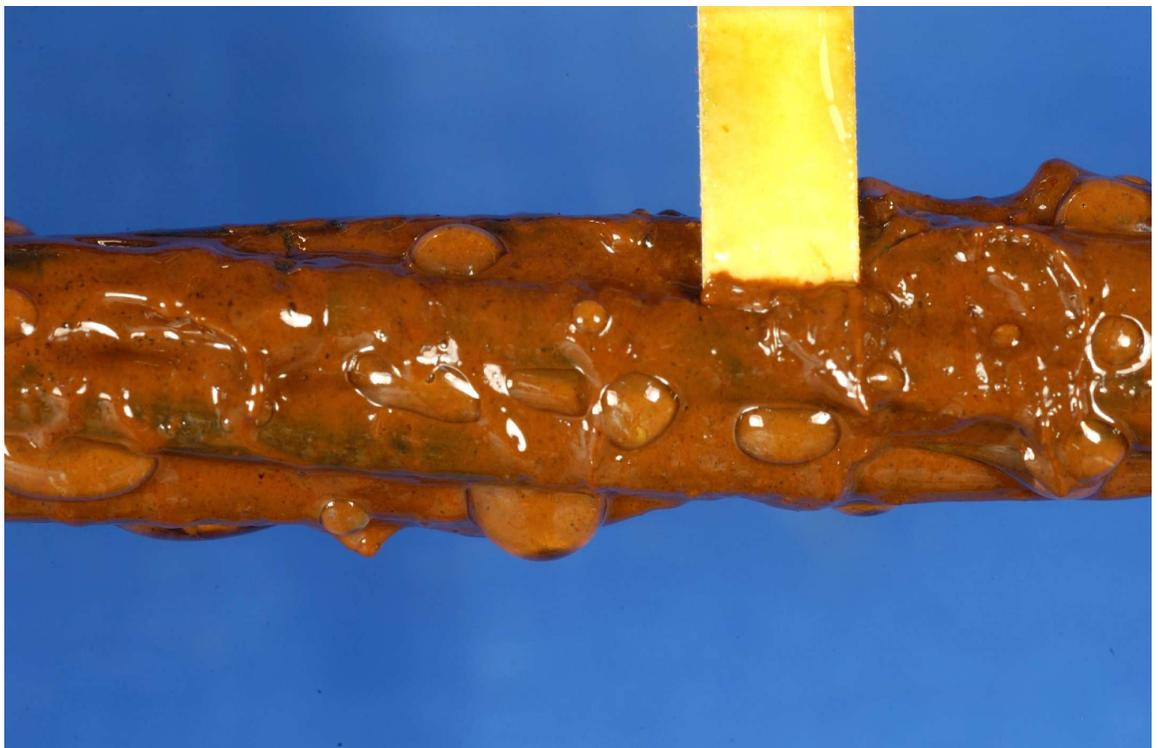
**Figure 10.** pH indicator strip placed in contact with wetted grease; color reaction indicates a pH of 3.5 when compared to color scale in Figure 7.
