**Summary Report  
Condition Reassessment and  
Post Tension Strand Evaluation  
25 Sigourney Street  
Hartford, Connecticut**

**DCS Project No. BI-2B-034A  
Architects Project No. 206063**

**13 October 2011**

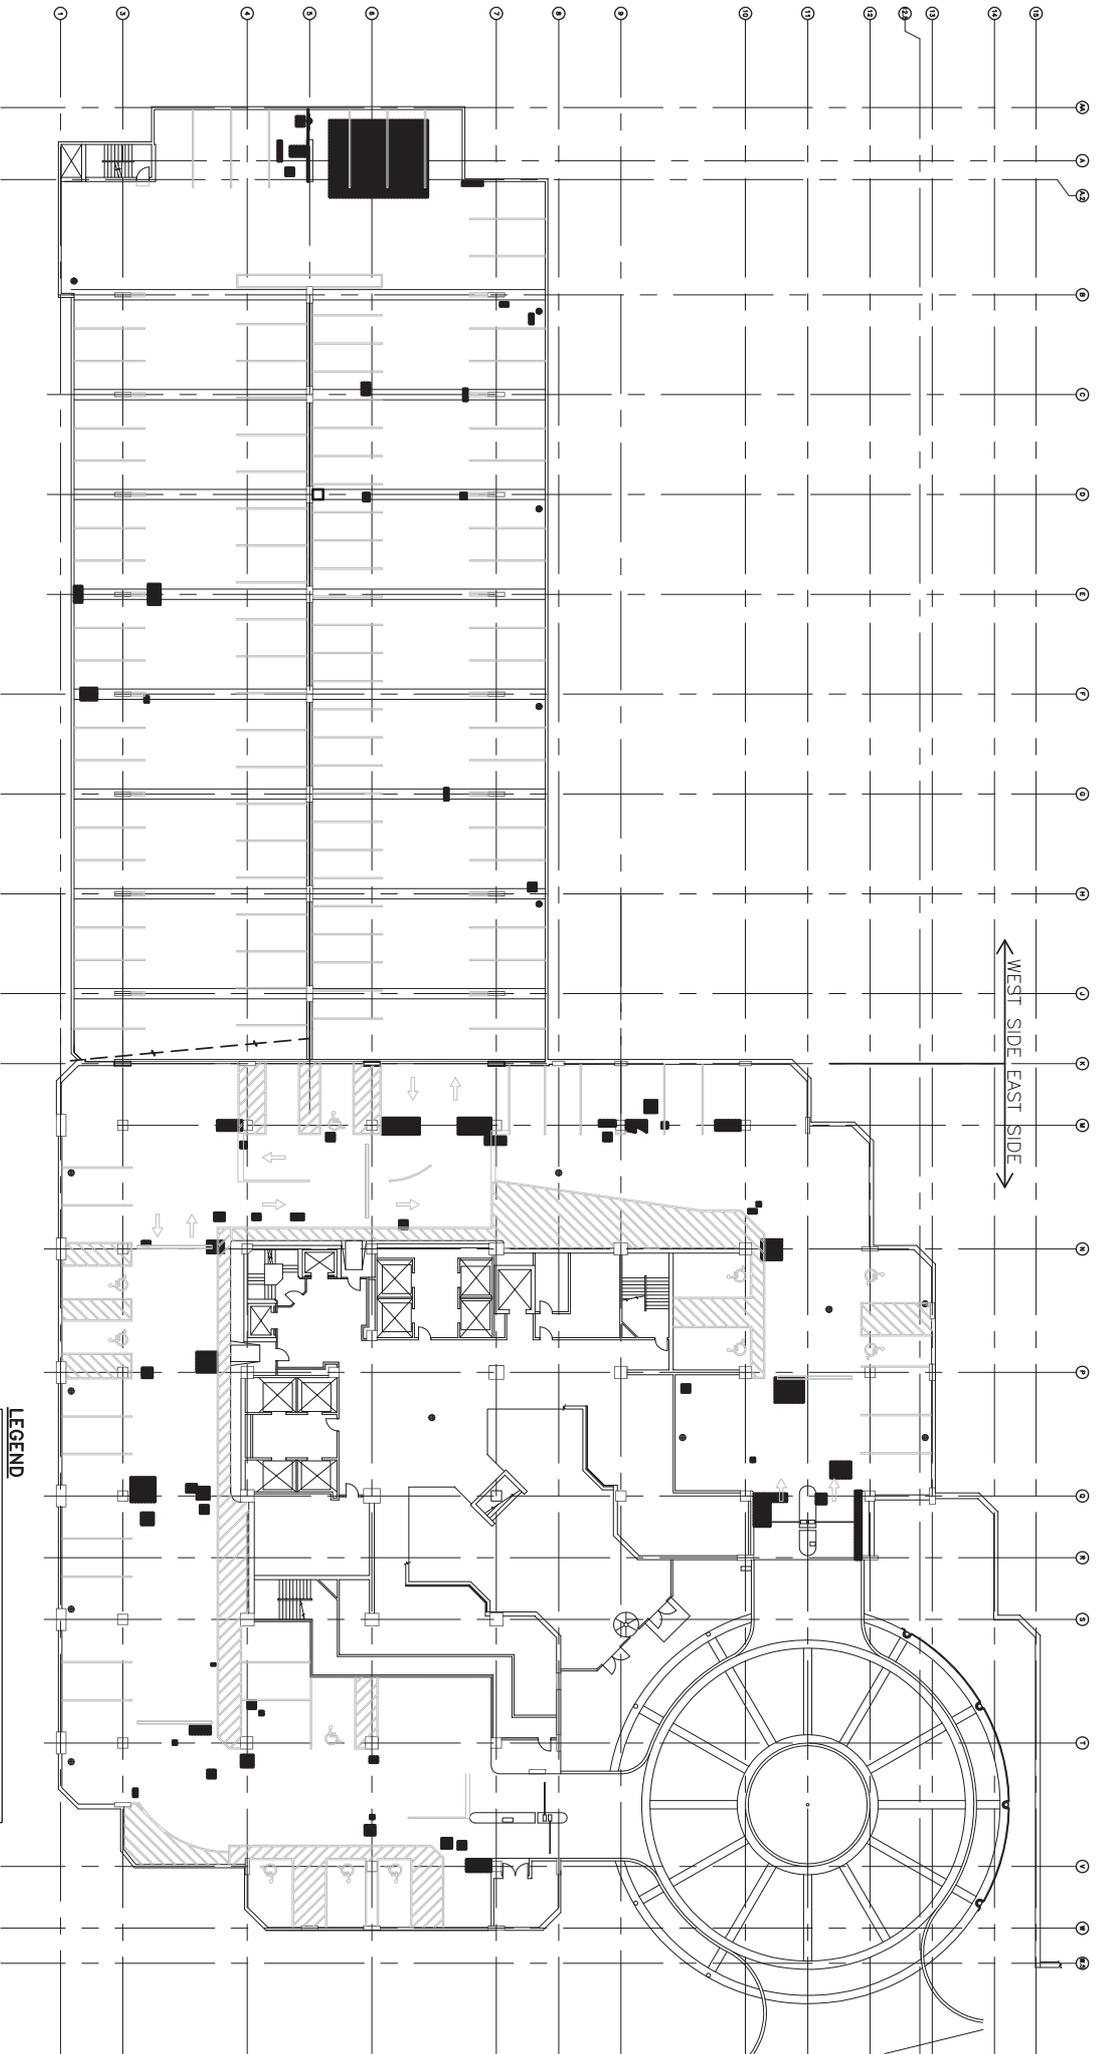
**4** PARKING LEVEL P4 - 2006 DECK LAMINATION SURVEY  
SCALE: 1/32" = 1'-0"

**LEGEND**  
EXISTING CONCRETE DELAMINATION / SPALL AREA

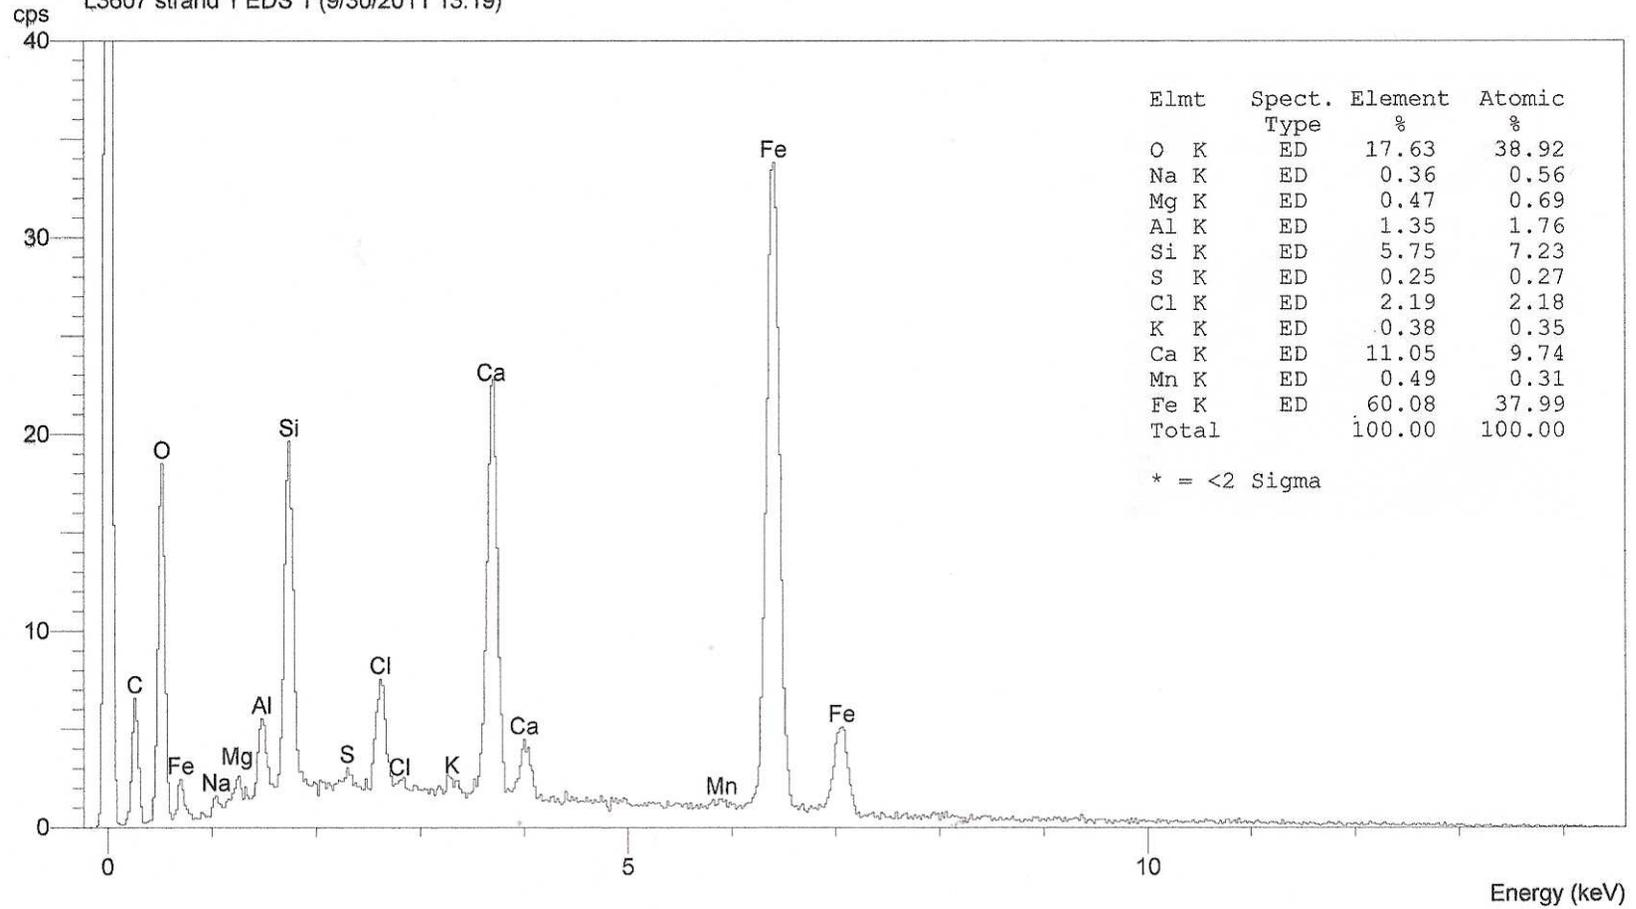
Strand 1, EDS 1.

Operator : MAIC Analysis  
 Client : none  
 Job : Job number 1  
 L3607 strand 1 EDS 1 (9/30/2011 13:19)

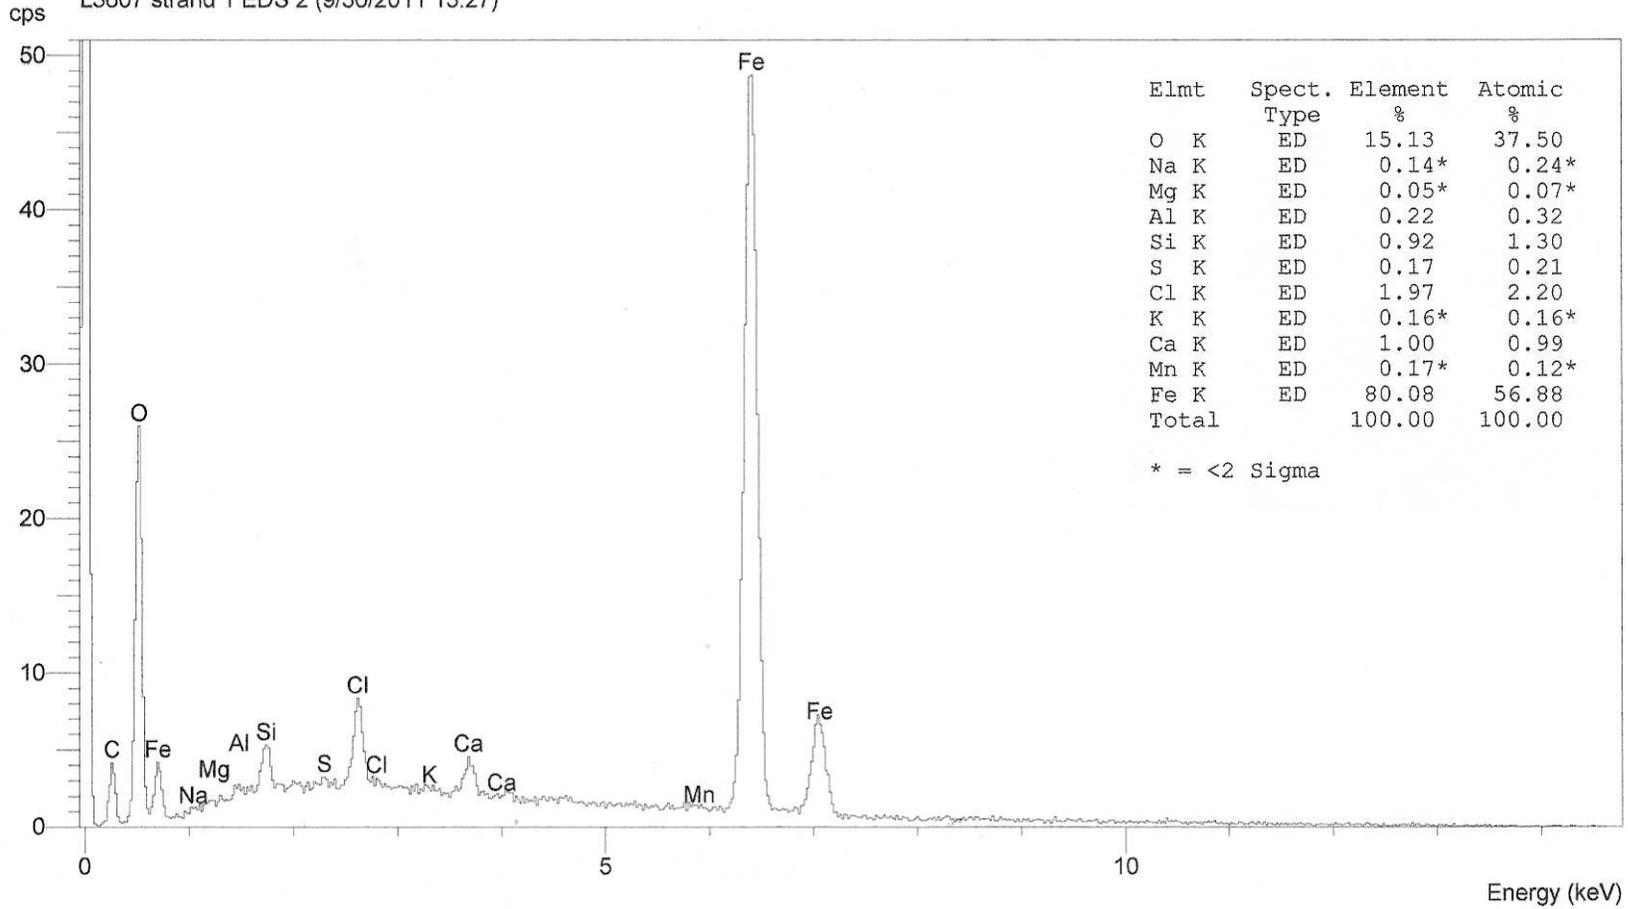
Strand 1, EDS 2.

Operator : MAIC Analysis  
 Client : none  
 Job : Job number 1  
 L3607 strand 1 EDS 2 (9/30/2011 13:27)

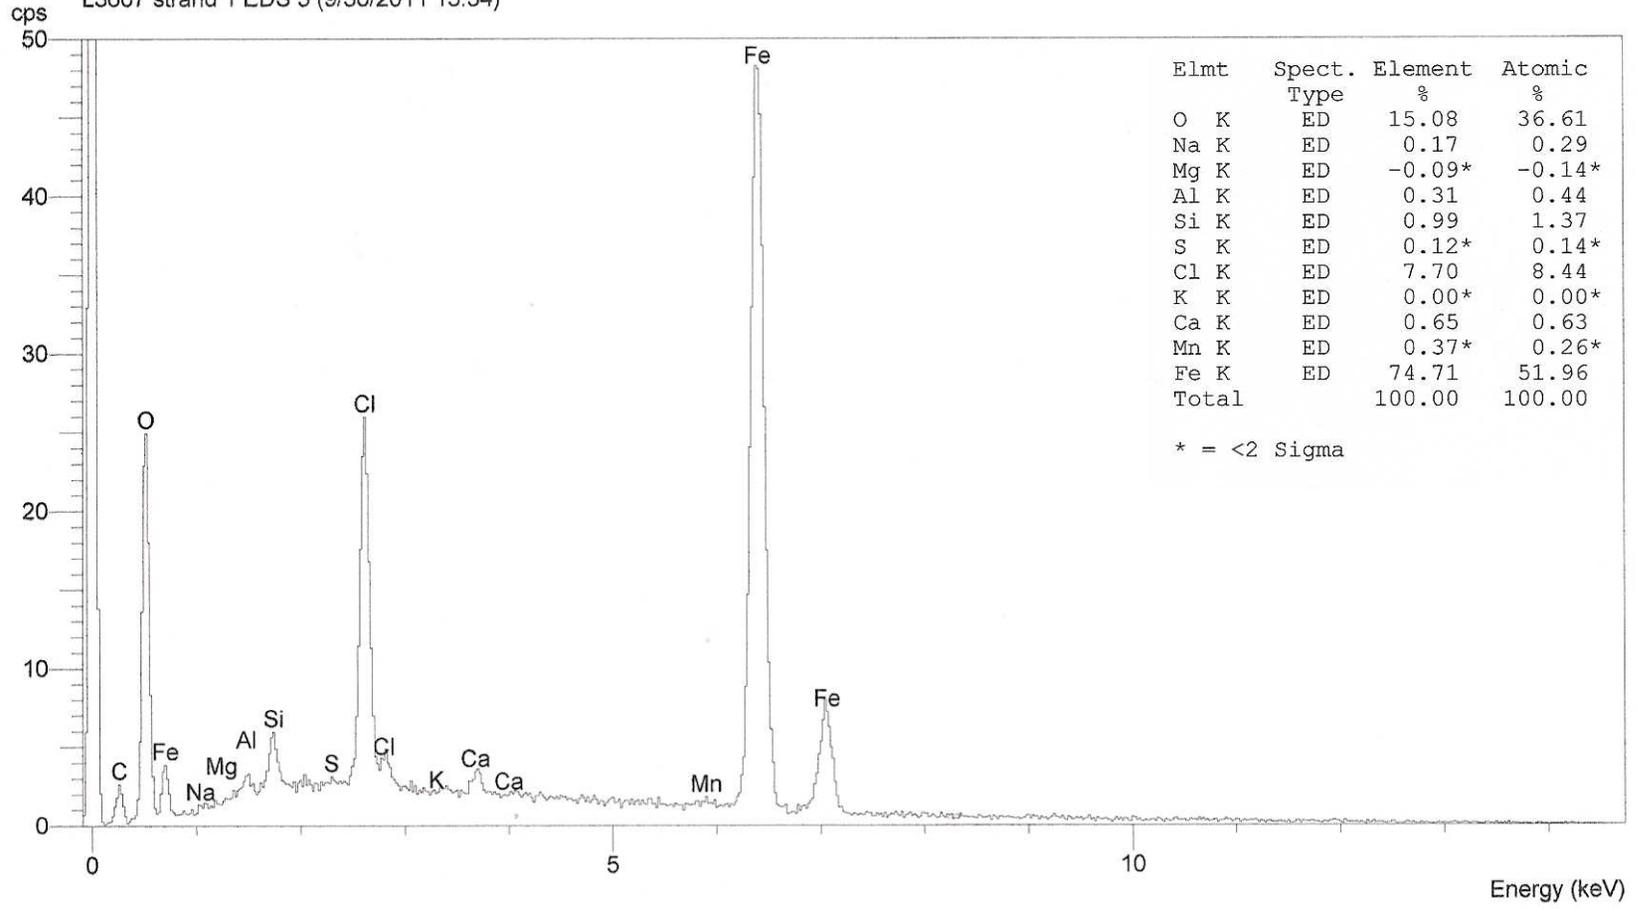
Strand 1, EDS 3.

Operator : MAIC Analysis  
 Client : none  
 Job : Job number 1  
 L3607 strand 1 EDS 3 (9/30/2011 13:34)

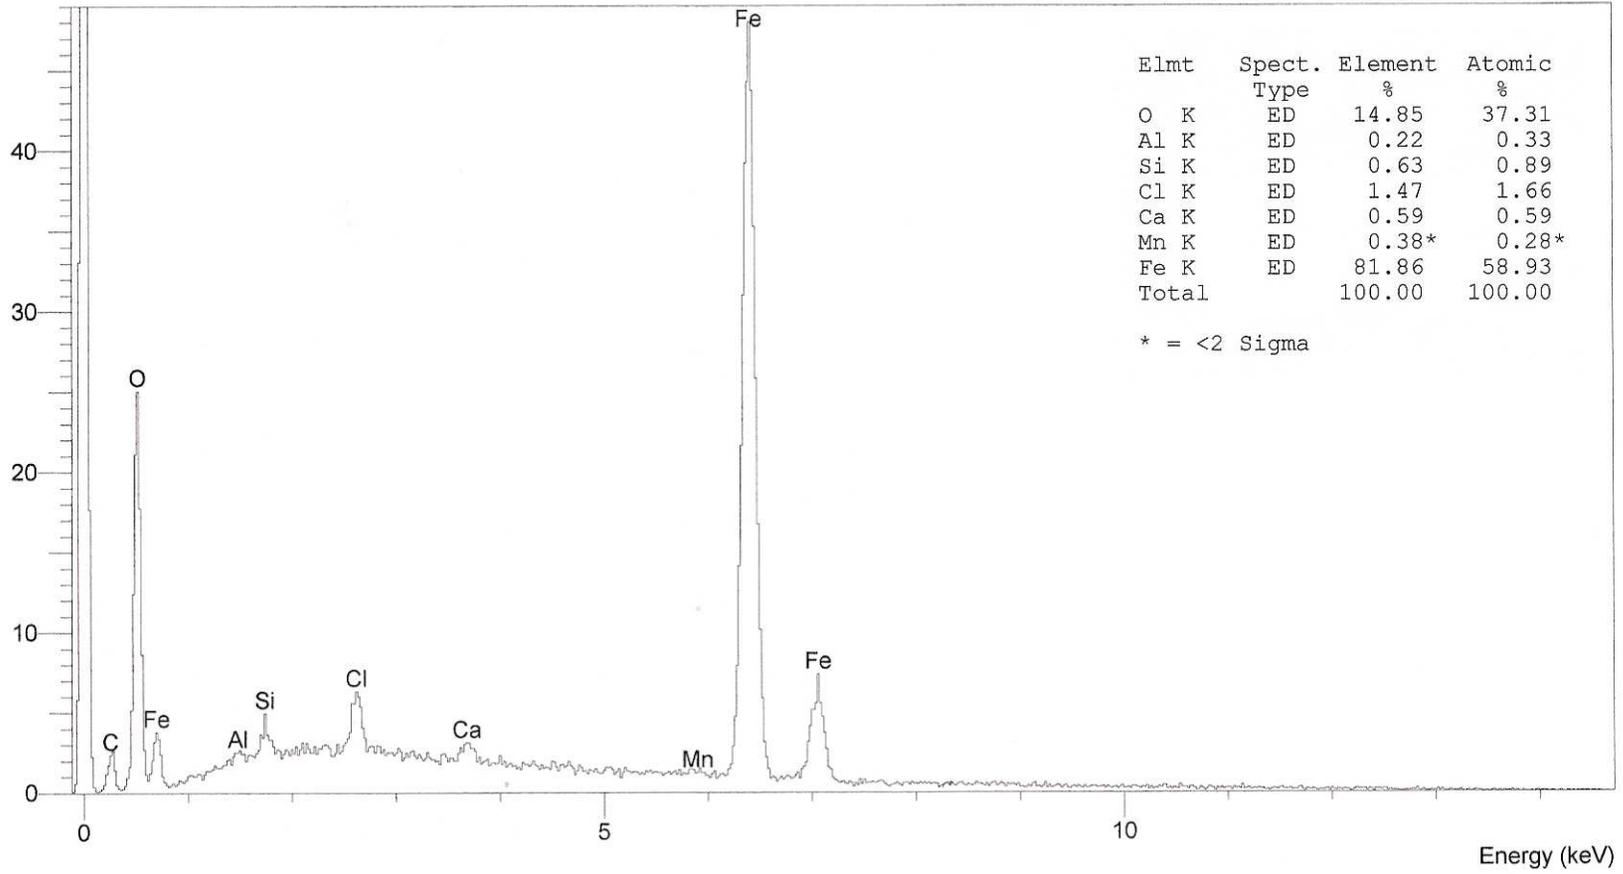
Strand 2, EDS 1.

Operator : MAIC Analysis  
Client : none  
Job : Job number 1  
L3607 strand 2 EDS 1 (9/30/2011 13:50)

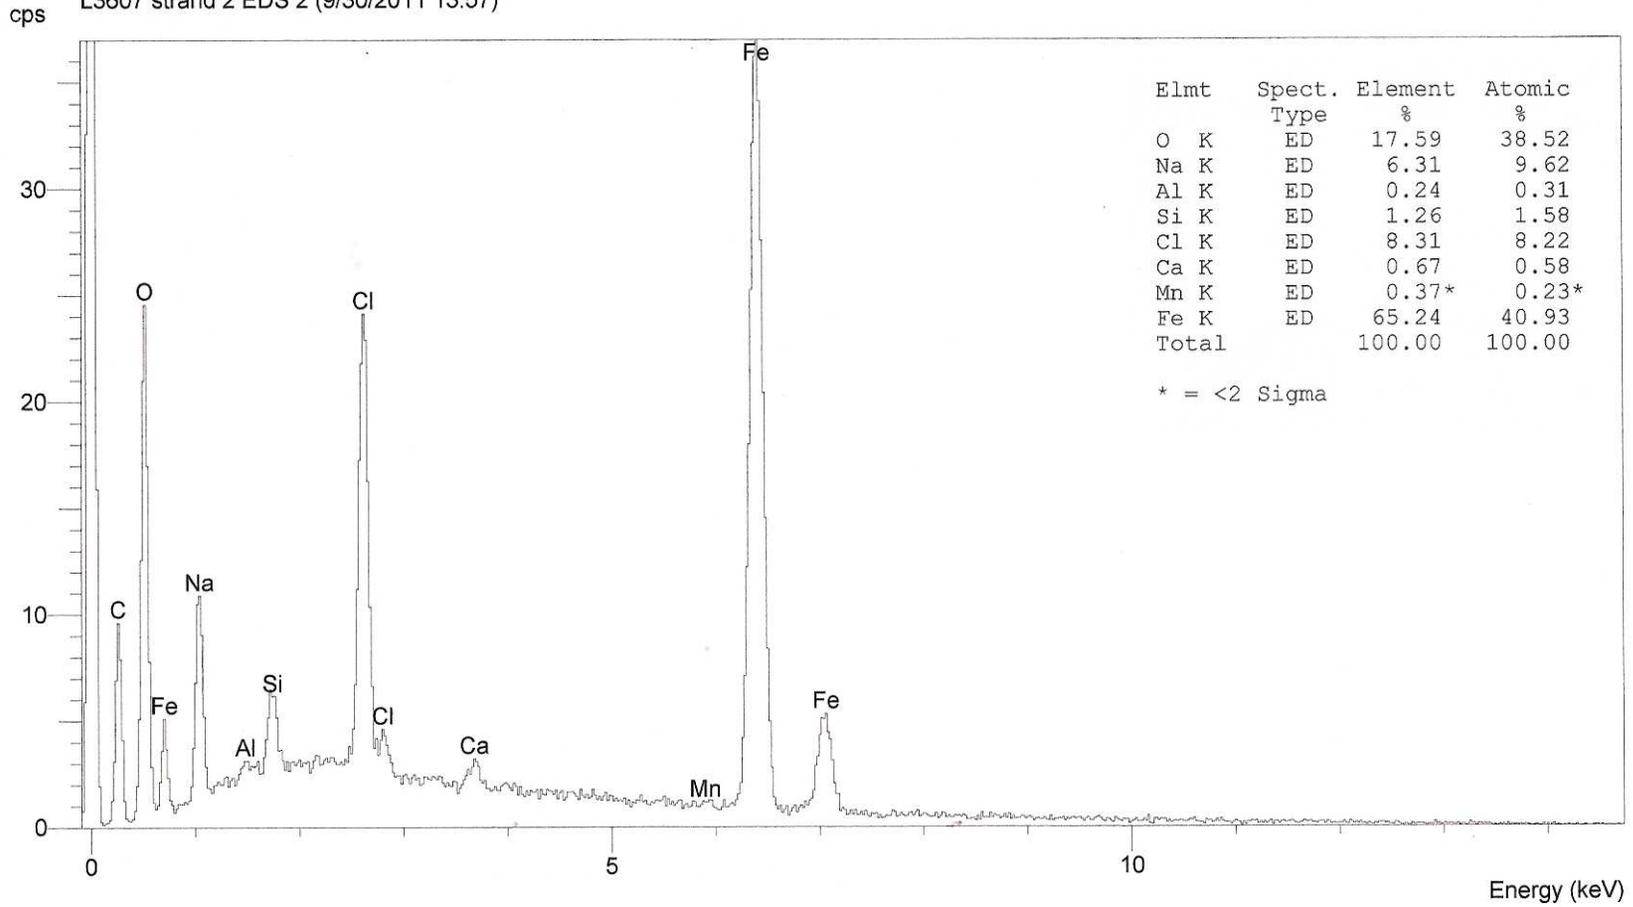
Strand 2, EDS 2.

Operator : MAIC Analysis  
Client : none  
Job : Job number 1  
L3607 strand 2 EDS 2 (9/30/2011 13:57)
